Excerpt from the 2023 Anoka Water Almanac

CHAPTER 7: MISSISSIPPI WATERSHED

Prepared by the Anoka Conservation District

HIGHLAND LAKE AQUATIC VEGETATION REPORT

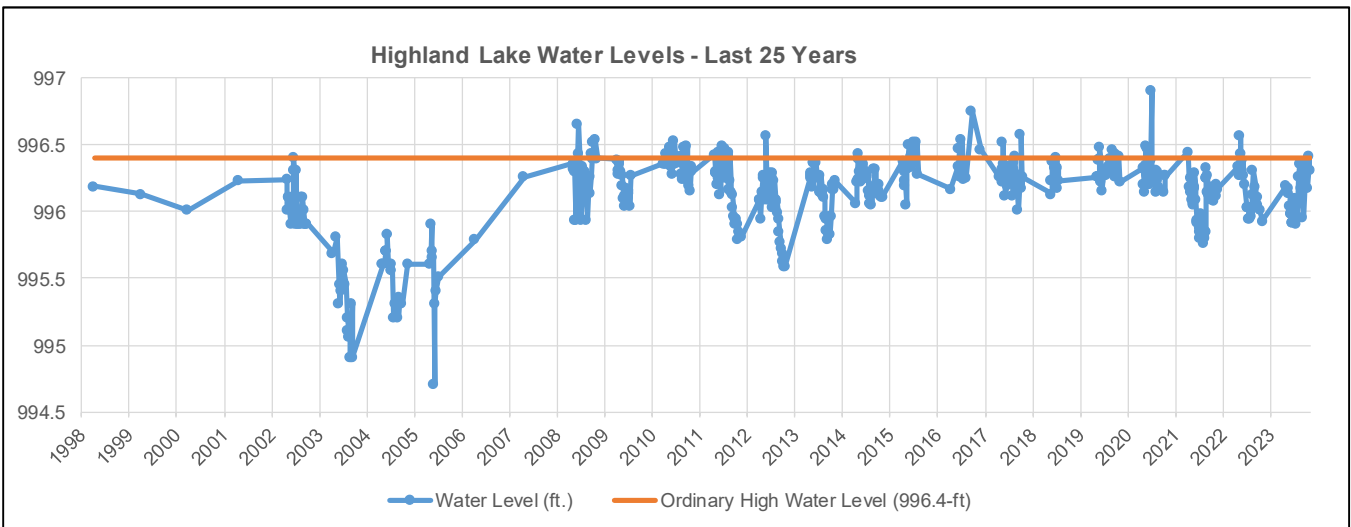
Highland - Lake Levels

Highland. Water levels in Highland Lake fluctuated 0.51 feet during 2023. Water levels were within the range observed in many years, but also had some readings on the lower end of that range due to drought.

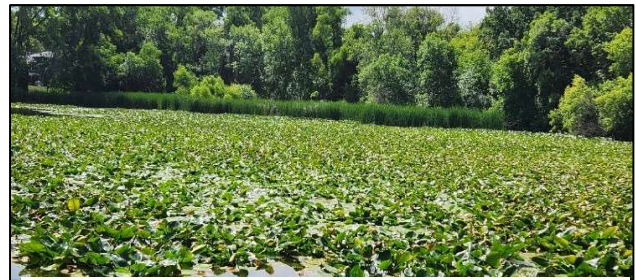
The native water lily *Nuphar variegata* (commonly known as Bullhead or Variegated Yellow Pond Lily) is the dominant aquatic plant in Highland Lake, and the only rooted floating species detected in this survey. Its floating leaves occupy approximately 85% of the lake's surface, typically growing so densely that they overlap or even rise above each other (Figure 2), shading out the water underneath entirely. *Nuphar variegata* is common in Minnesota and grows in quiet shallow waters with mucky bottoms. Water lilies spread through rhizomes underneath the sediment and are often abundant in nutrient-rich ponds and lakes with shallow water throughout. Common duckweed (*Lemna minor*), a free-floating plant, was also detected in Highland Lake but generally in low quantities amongst the stands of emergent vegetation. See Appendix A for a map of floating vegetation prevalence and abundance.

Figure 2. Dense Bullhead Water Lily (*Nuphar variegata*) growth in Highland Lake.

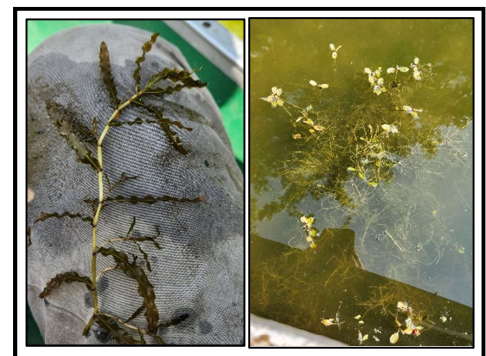
Curly-leaf Pondweed (*Potamogeton crispus*): This is a prohibited invasive species in Minnesota which often grows in dense mats and outcompetes native aquatic vegetation (*Figure 2*). It was detected along Highland Lake's northern and western shorelines (Appendix D), but is present at low densities and often growing alongside Vasey's Pondweed. Curly-leaf pondweed growth was reduced in many metro area lakes this year due to heavy snow cover and late ice-off, so its growth in Highland Lake may typically be more abundant.

This is a narrow-leaf pondweed species which does not have existing herbarium or MNDNR survey records for Anoka County and is otherwise uncommon in the Twin Cities Metro Area. It was the most common submersed plant found in Highland Lake, occasionally growing in dense clusters (*Figure 3*). The leaves of Vasey's Pondweed are very fragile and thus susceptible to disturbance from boats or wave action; this may be one reason that it's able to persist in Highland Lake. Identification was confirmed with staff from the MN Biological Survey.

P. crispus (left) and dense *P. vaseyi* growth (right) detected in Highland Lake

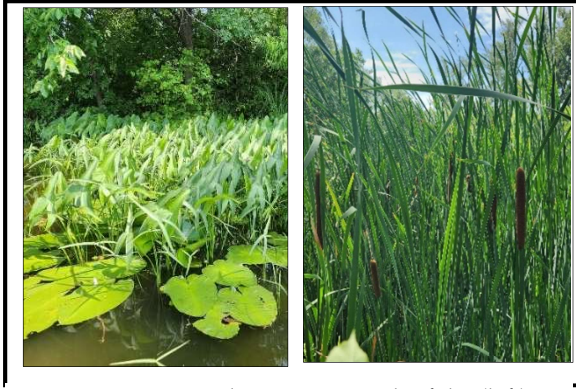
Figure 1. Emergent plants *Sagittaria latifolia* (left) and *Typha* spp. (right) observed in highland lake.

Cattails (*Typha* spp.) are the dominant emergent plant on Highland Lake. They occupy approximately 1/3 of the shoreline in dense but generally narrow fringes less than 50 feet wide. The dense growth patterns and flower characteristics of these cattails indicate that they are likely *Typha x glauca*, which is a hybrid of the native broad-leaved cattail and invasive narrow-leaved cattail. However, DNA analysis is typically needed to confirm the identification of this species. Hybrid cattails are increasingly common in lakes and wetlands, especially in those receiving nutrient-rich runoff. They often expand rapidly in shallow water via underground growth, choking out other aquatic vegetation in the process.

Broadleaf Arrowhead (*Sagittaria latifolia*) is present in small clusters along approximately 5% of the lake's shoreline. This emergent plant is native and common in Minnesota's aquatic ecosystems. The remainder of the lake's shoreline lacks emergent vegetation, instead containing a narrow zone of exposed sediment which quickly transitions to riparian shrubs upslope. See Appendix E for a map of emergent vegetation distribution.

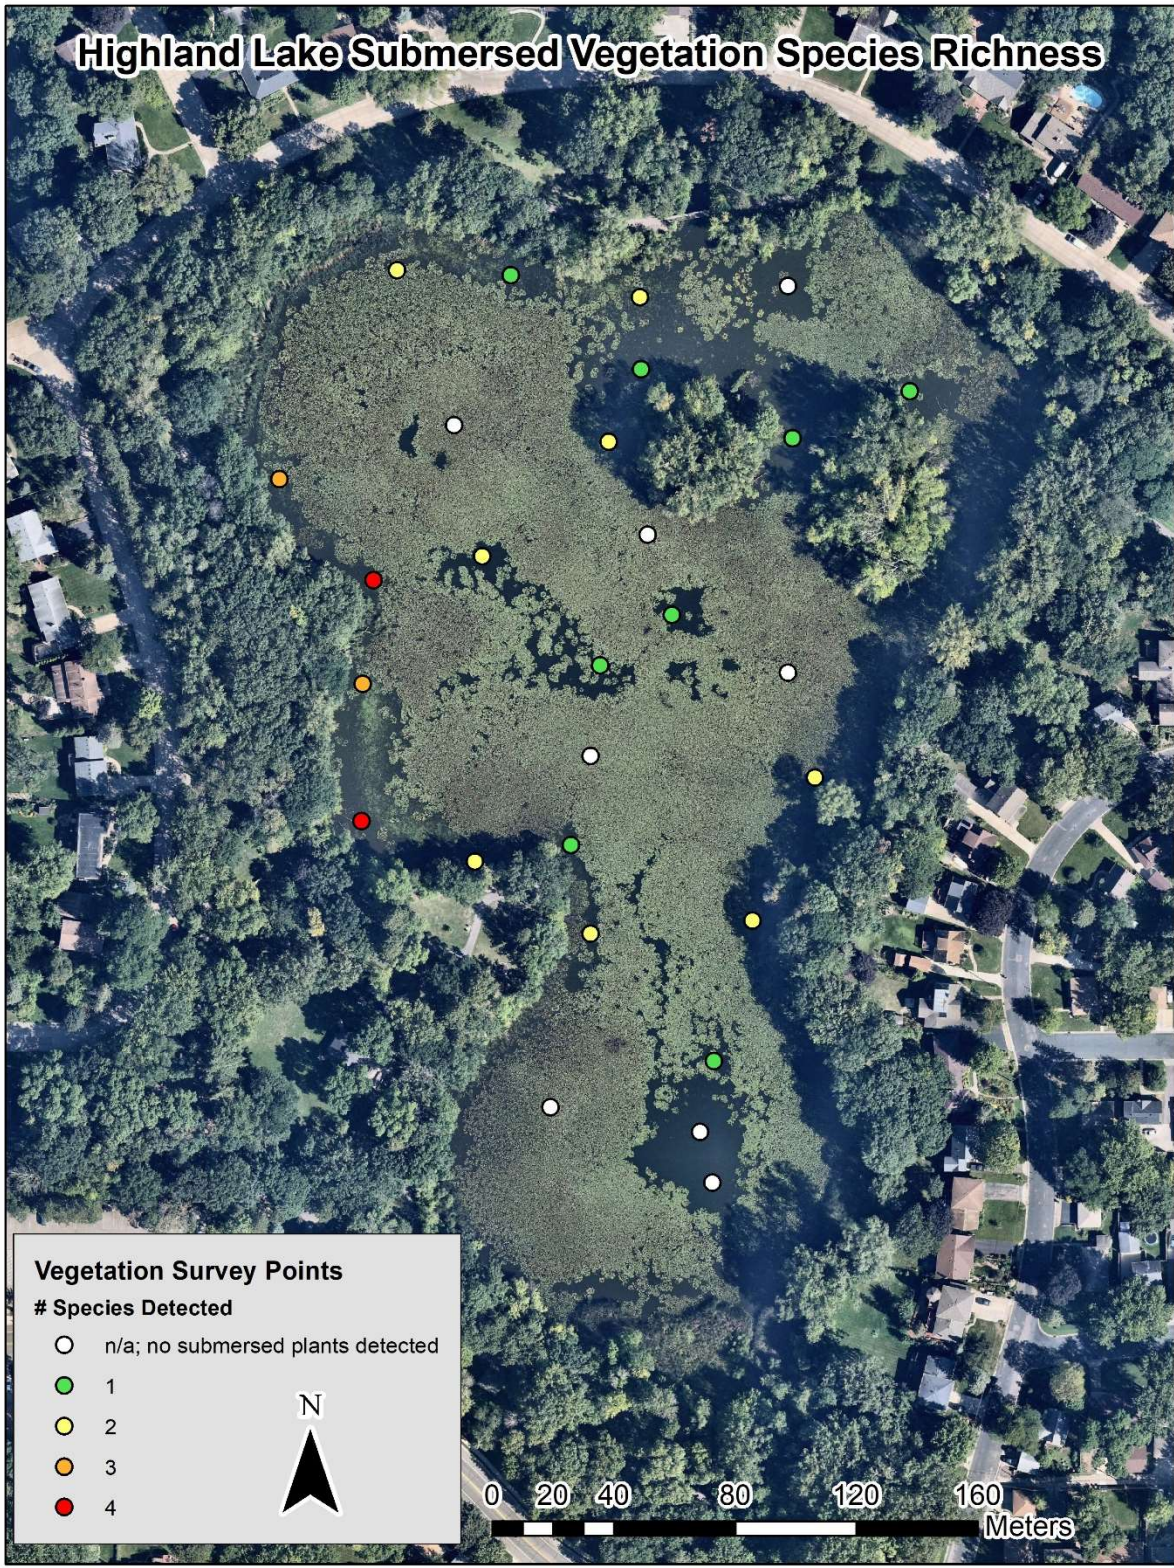
Overall, there is a low abundance of submersed vegetation on Highland Lake. This is likely due to two primary factors: turbid (cloudy) water conditions and the widespread coverage of dense lily pads, each of which reduce sunlight reaching the lakebed and restrict the growth of submersed plants. Submersed plants were not detected at any points containing a floating vegetation biomass rating of 3, or at water depths exceeding 2.5 feet. They are most prevalent in the shallow, lily-free patches of water around the edges of the lake and its islands.
